Application for membership

Candidate's Report on Technical Experience

I joined **Company Name** in February 2018, and I worked as Project Manager for the past 3 and a half years. Since the moment I joined the specialist façade contractor I have been responsible for the execution of a mixed-use project in London named **The Project**. Throughout this period of time I was responsible for a wide range of project phases, including PCSA, Pre-Construction, and Construction.

This report is focused on one of the most difficult technical challenges I had to manage across the whole project execution, and it is related to the coating of the external shopfront cladding for the retail unit assigned to the international luxury brand **The Tenant**. The development of a suitable solution for this specific application required a long and complex façade engineering process, which I had to lead on behalf of **The Façade Specialist Contractor**. The process involved colleagues from our sister company in Italy, but also external experts, suppliers and applicators.

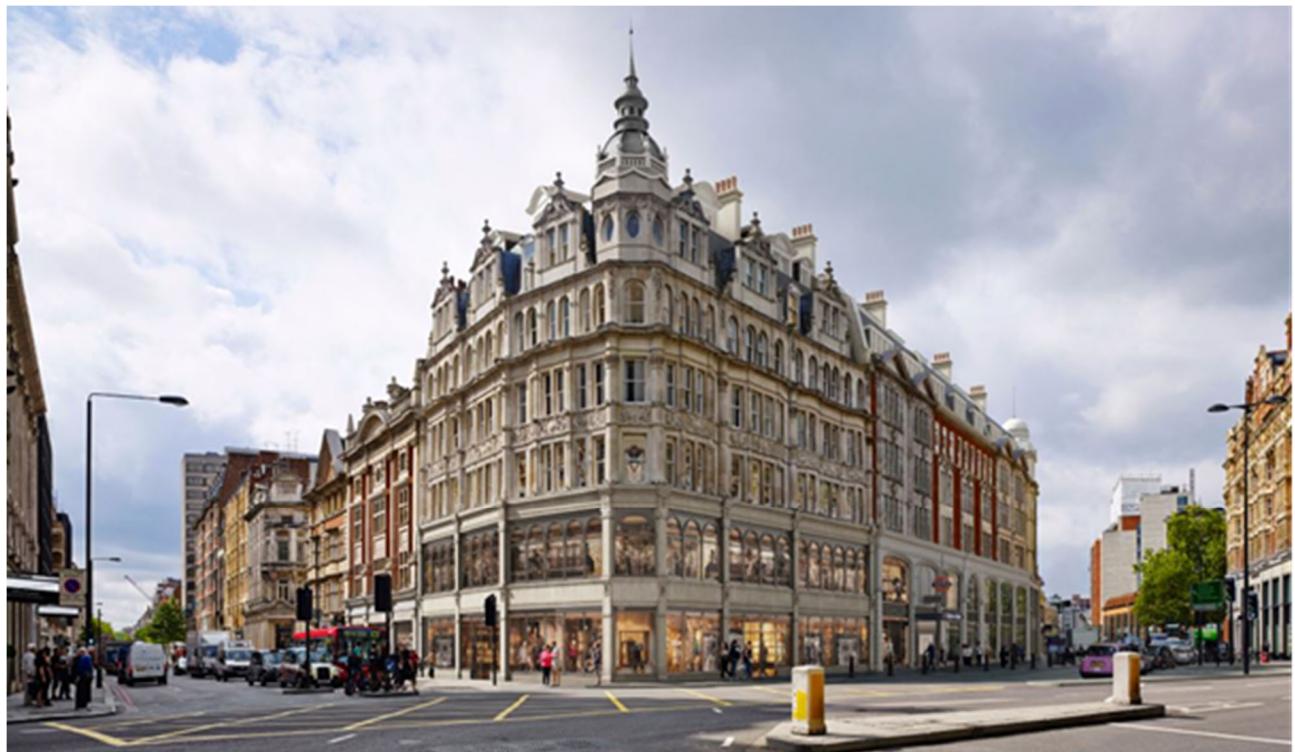
IMG01 – CGI representing **The Project** viewed from the corner between Brompton Rd and Sloane St

The Project is a mixed-use development in central London, located between Harvey Nicholson and Harrods in Brompton Road. The project, developed by **The Architect**, comprises a suite of residential apartments, office spaces, retail units, a rooftop restaurant, and a renewed underground entrance. The original buildings were partly demolished and partly refurbished, depending on their listed grade. The majority of the original facades were maintained, and new built glazed shopfronts were erected within the existing openings at ground and first level.

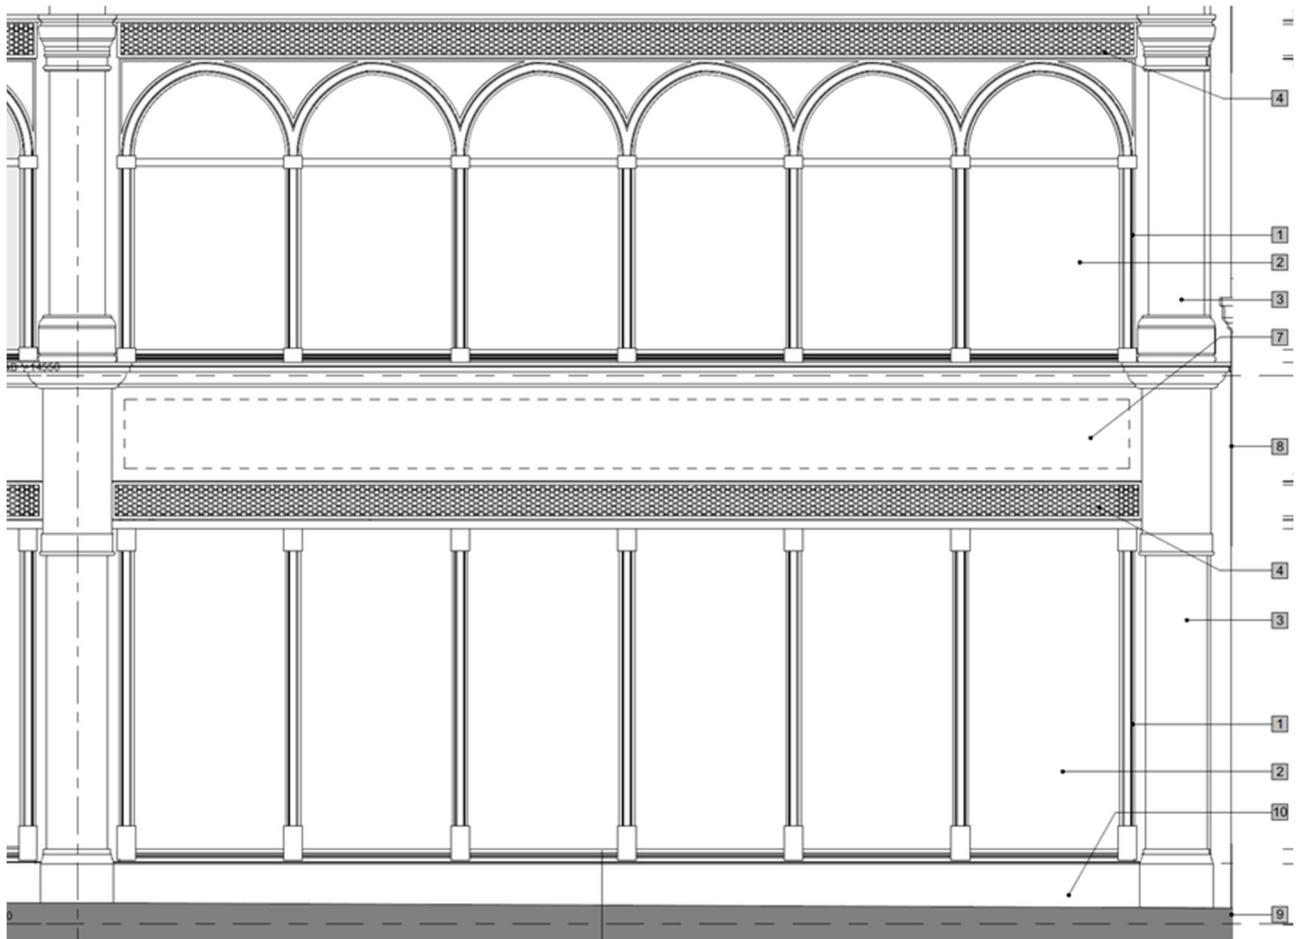
IMG02 – Elevation developed by **The Architect** for **The Tenant** shopfront

As mentioned previously, the glazed shopfronts located at ground and first floor were designed so that they could be installed within existing openings. **The Architect** developed an architectural design based on glazed windows cladded externally and internally with metal components, to match the visual appearance of other high-end shopfronts in Brompton Road and Basil Street, Such as Harrods.

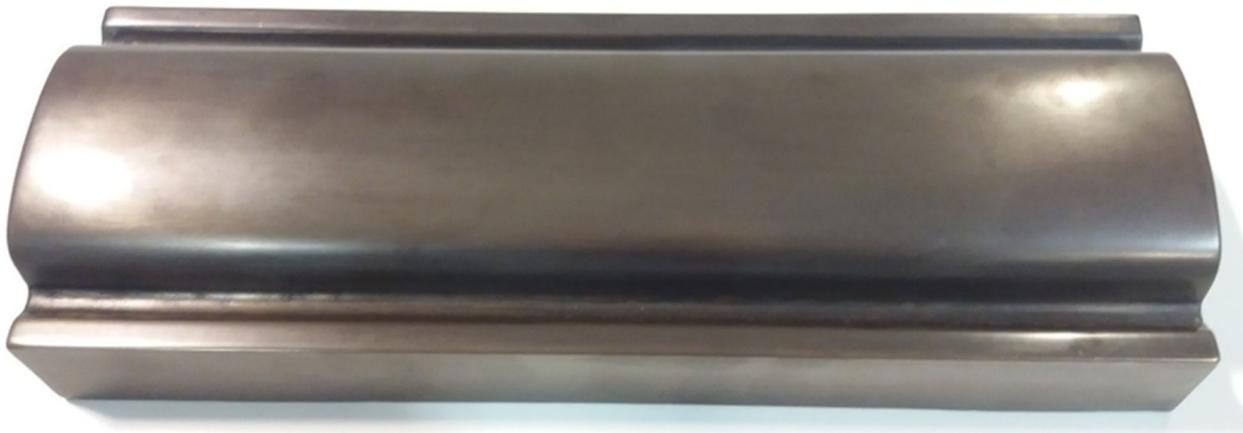
IMG04 – Aluminium component coated with a real bronze paint finish

During the design phase I led the discussion with the manufacturer of the aluminium cladding and also the supplier of the real bronze finish, as both items would have been procured in the UK. We obtained samples of the most typical cladding components, and we free issued those to the applicator of the specified finish so that they could be coated. Once this process was completed we offered the samples to the project team for review and approval.

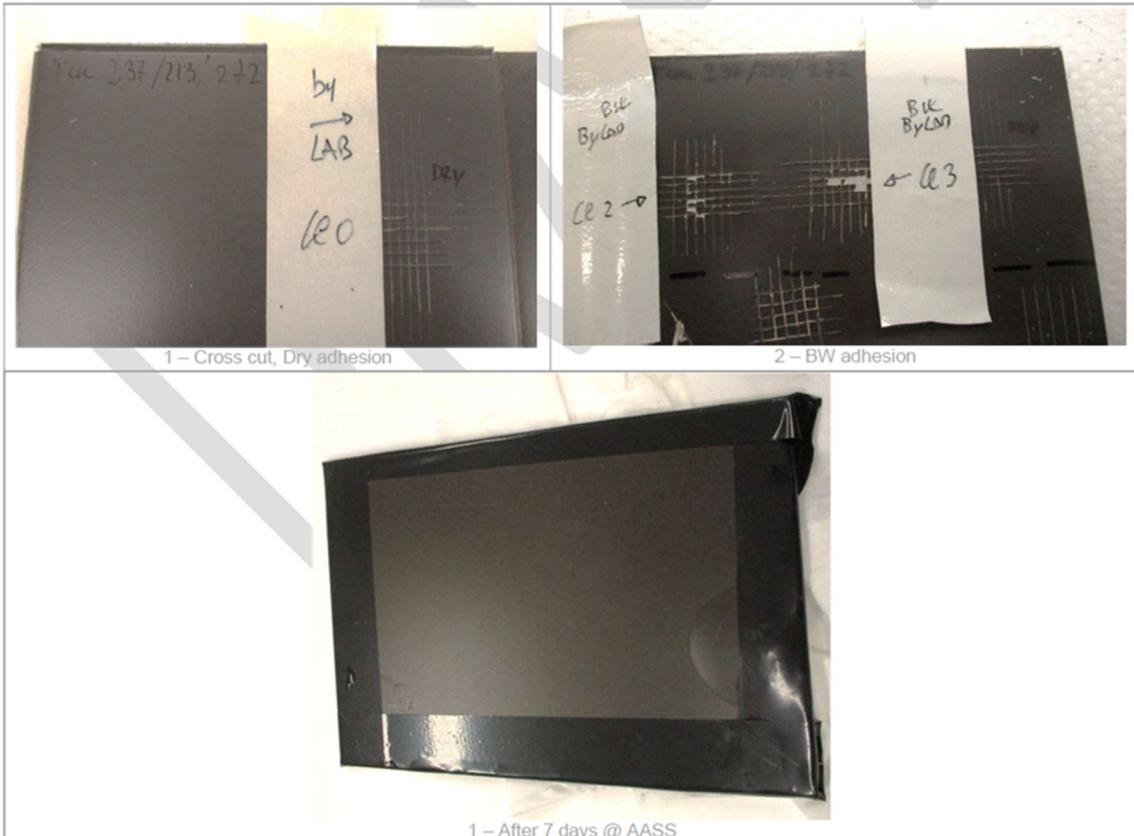
MATERIAL 1 - PICTURES

IMG05 – Table of Qualicoat tests completed on the specified finish and results obtained after the initial testing campaign

The results of the initial testing campaign completed by **The Façade Specialist Contractor** provided us with the evidence that the specified finish was not suitable for an external use, as it did not confirm to the Qualicoat standards. Based on this new evidence we decided to inform **The Employer**, and to commence the process that led us to identify a suitable solution.

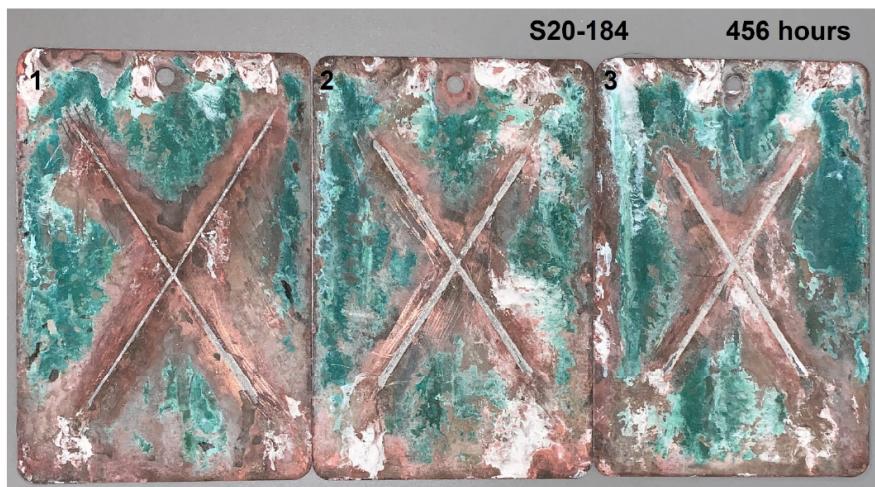
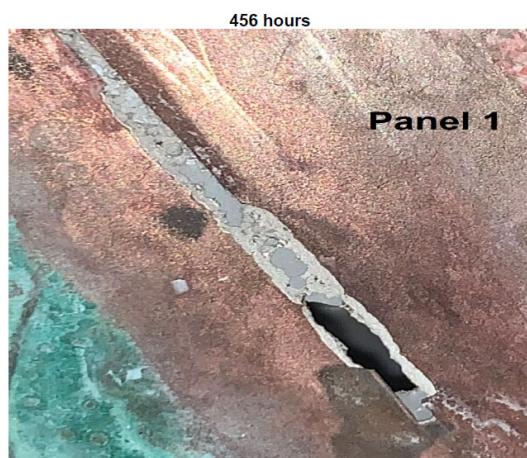
**LABORATORY REPORT S20-184**

IMG06 – Finish degradation after only 456 hours of the AASS test completed by an independent laboratory

After receiving the test results on the specified finish, and in absence of a full paint system detailed in the Project Specification, it became apparent that a new, performative paint system was needed in order to meet the project requirements. This conclusion was further substantiated by the results of an independent performance test completed by the paint manufacturer/applicator, which confirmed negative results, and showed a severe degradation of the finish far earlier in the test than the 1000 hours of Qualicoat water testing process (Acetic Acid Salt Spray testing).

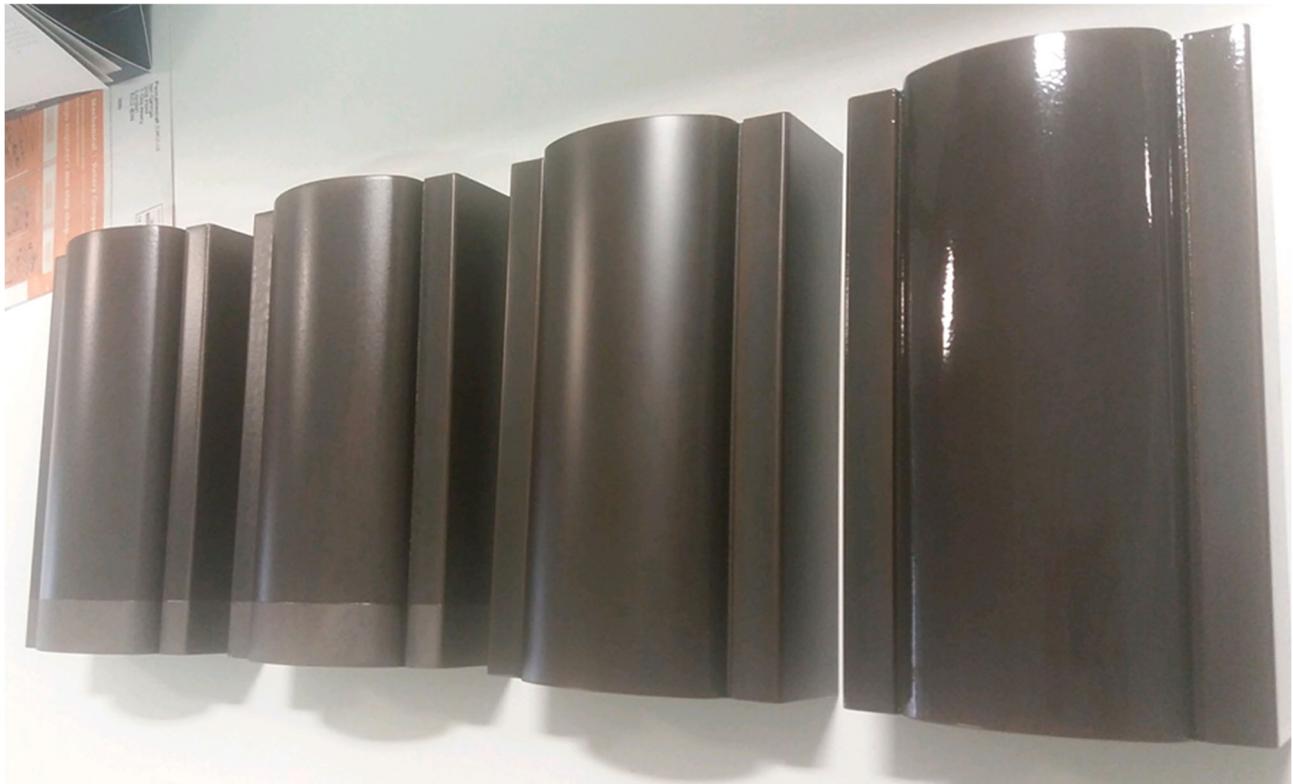
IMG09 – Comparison between different options of top coats for the liquid paint coating

With regard to the selection of top coatings, and after reviewing all the five samples provided by different manufacturers, I decided to proceed with one single product (Option 1 of the table in IMG07), as all other alternatives could not achieve the level of visual appearance required by **The Employer**. Streamlining the process in such a way certainly constituted a risk for the project, as it allowed us to test only one option for the top coat. At the same time, it allowed us to limit the amount of testing activities to be completed, and expedited the whole

process. When the team moved to the next step of testing activities, only six options had to be processed rather than 30 (combining five top coat solutions with six pre-treatment options). This decision explains why the table in IMG08 only features one top coat product for all samples tested.

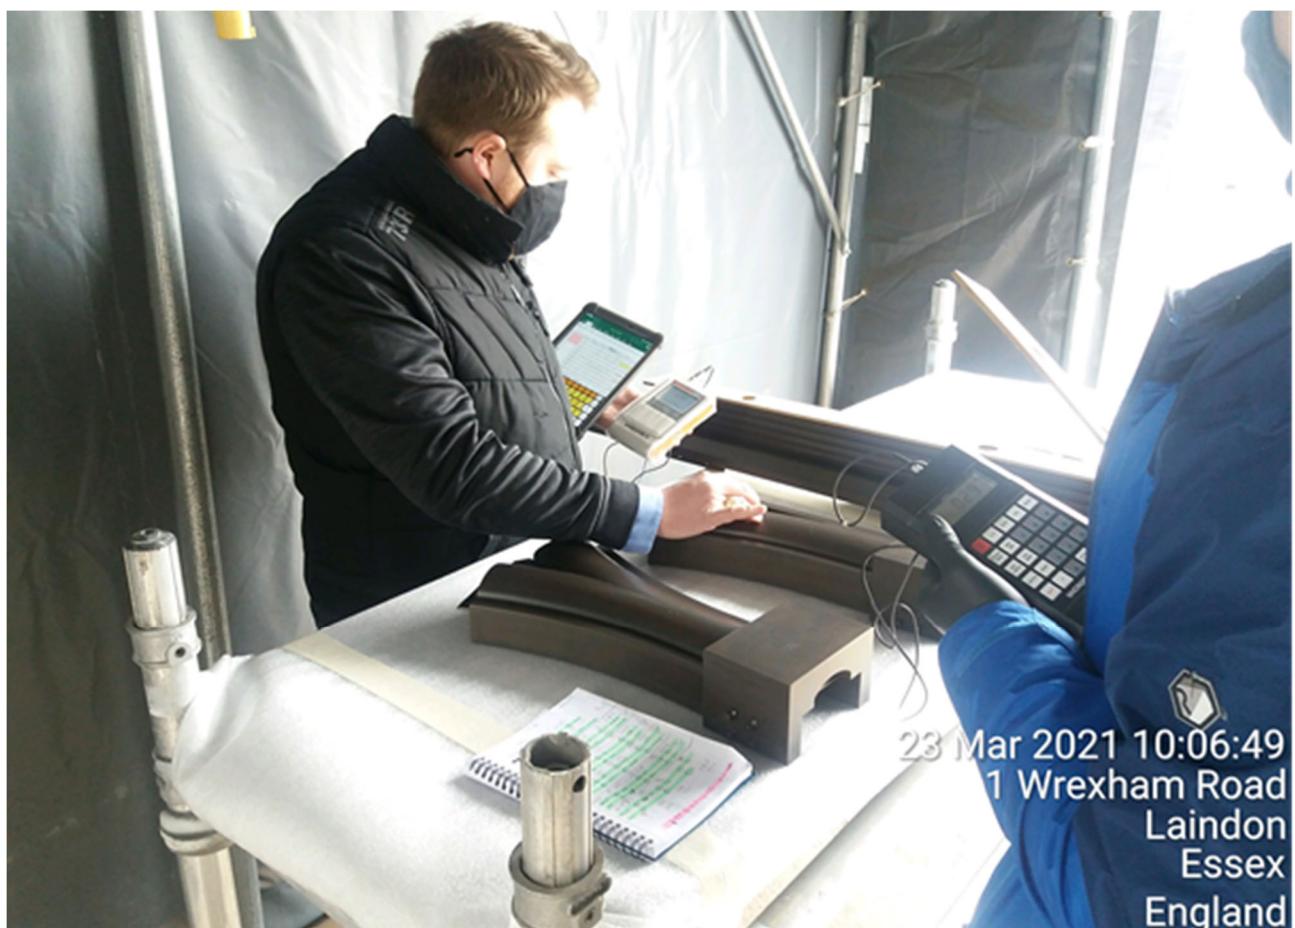
IMG10 – Third party inspection for the first batch of aluminium cladding components completed by **The Paint Specialist**

In addition to the ITP to be followed by the applicator, I appointed **The Paint Specialist** as independent inspector to obtain third party assurance that the quality plan established by our organization was suitable for the specific application and adopted correctly by the supply chain. A number of independent inspections were held during the production process, both at the pre-treatment plant and the facility where the liquid paint finish was applied.

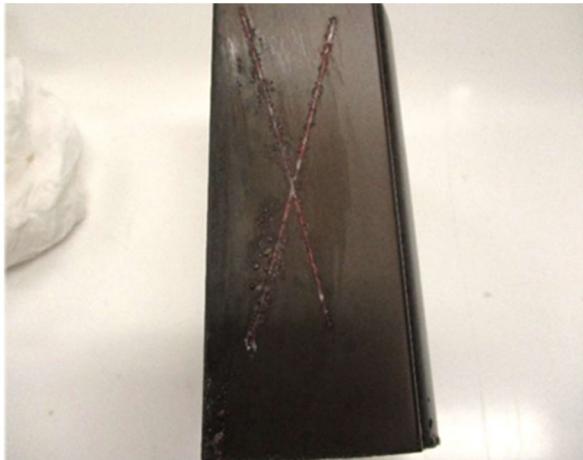
9 – AASS, 480h – FACE 1

IMG12 – Improved finish degradation observed after 1000 hours of AASS testing with no signs of corrosion

The Qualicoat testing process completed by The Façade Specialist Contractor was extensive, due to the large number of batches to be analysed, and the 1000-hour duration per every AASS to be completed. It required four months of activities in total, at the end of which the Quality Department issued a final report drawing the final conclusion with regard to the predicted performance of the external aluminium cladding of the shopfronts, exposed to an external environment. The report highlighted that all the batches tested during the main production process behaved in the same manner as per the original sample of Option 2, and it was therefore indicative of an acceptable behavior in terms of performance. It should be noted that, according to the strict Qualicoat standard, all the AASS test results for the different batches were classed as Not Conform, however the results observed at the end of the testing process were deemed as acceptable, subject to the definition of an appropriate maintenance regime.

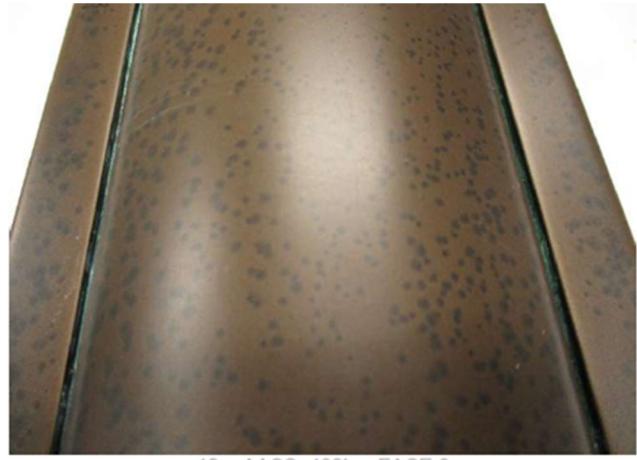
10 – AASS, 480h – FACE 3

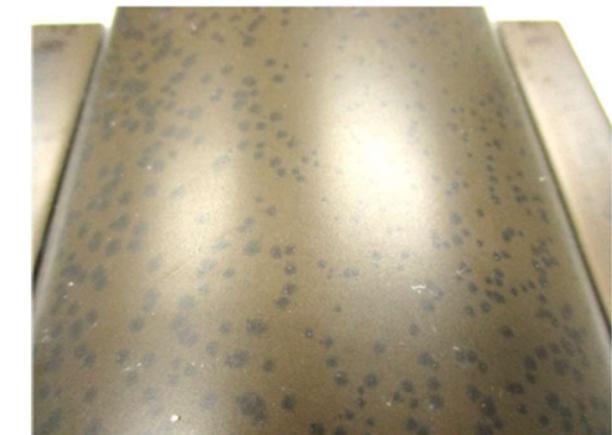
12 – AASS, 1000h – FACE 3

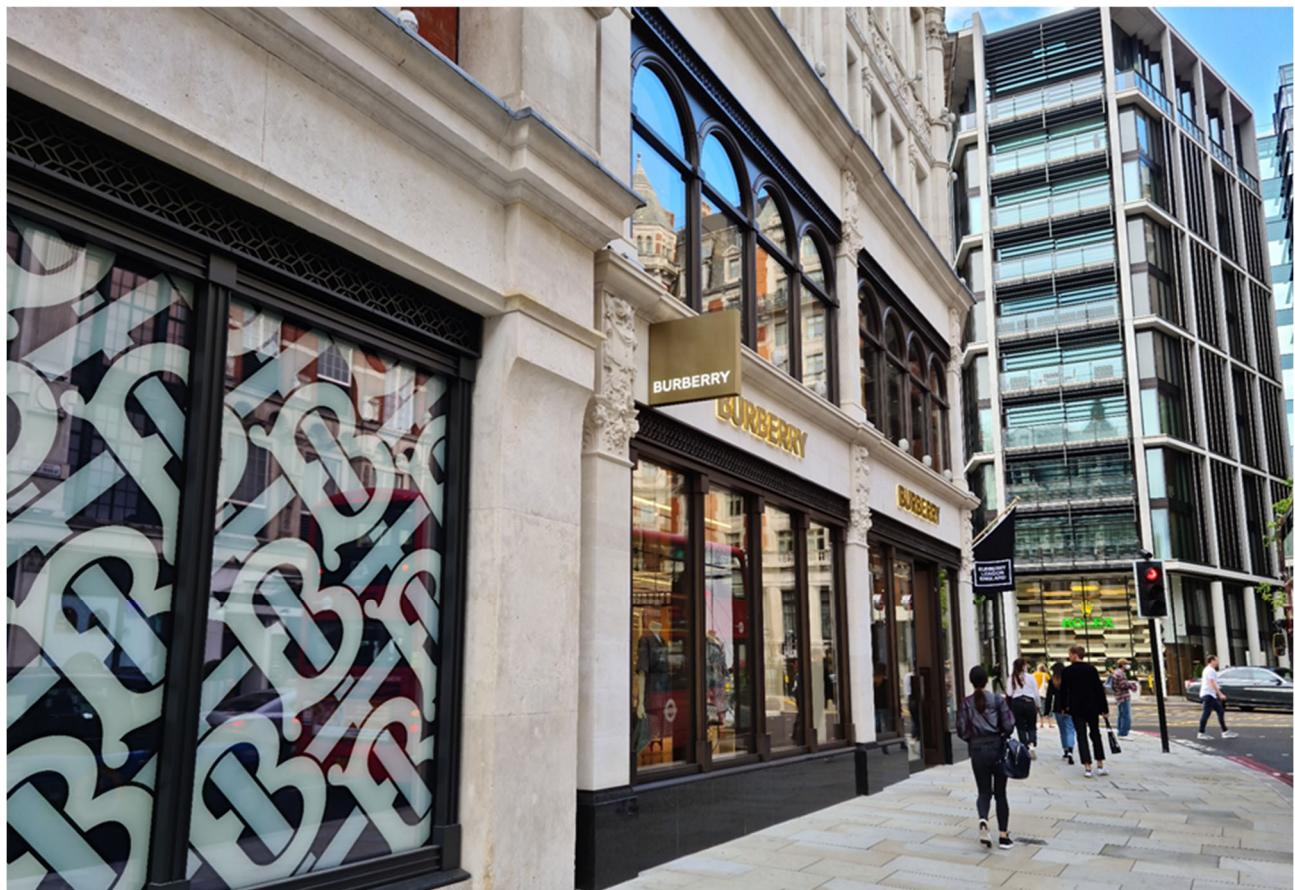
IMG13 – **The Tenant** storefront open to the public featuring our bespoke bronze paint system
