**TYNTESFIELD HOUSE, WRAXALL,
NORTH SOMERSET**

REPORT & ASSESSMENT OF THE WAYGOOD LUGGAGE/PASSENGER LIFT

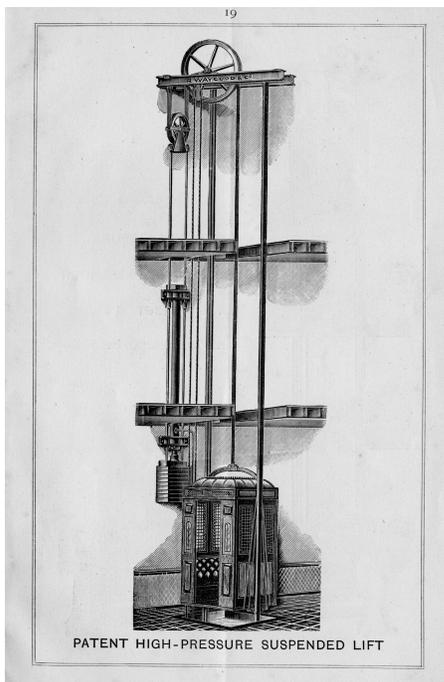
When I returned to the office I contacted a colleague in the United States, Dr Lee Gray, author of "A history of the passenger elevator in the 19th century". He kindly e mailed me a photograph of a Waygood elevator that bears some resemblance to the Tyntesfield House one which he had found in a Waygood brochure from the 19th century.

Picture from Waygood Brochure (P6)

Unfortunately the area where the cylinder is clad at the ground floor level isn't available for inspection without dismantling some of the fabric of the building however it can be confirmed that the spanning sheave arrangement is similar and the cylinder with a 2:1 reeving tied off at the top must also be similar due to the fact that it can only travel half the distance of the shaft.

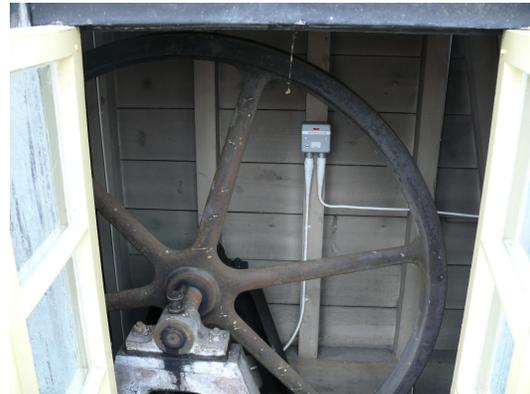
The spanning sheave, which is located in housing on the roof, can be seen below. The sheave measures 55" in diameter and has two rope grooves.

Spanning Sheave (P3)

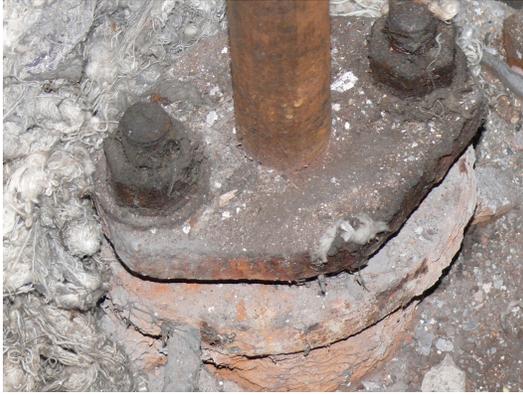
The top of the piston had been cut off at Level 1 and a bathroom installed on the floor above in the area where the piston used to operate. Evidence of this still exists with lines in the ceiling and a pipe still running round the shape of where the cladding would have been.

That having been said the depth of the ground floor cylinder timber cladding would allow for something else to be enclosed within it as the cupboard at the 1st floor where the piston has been cut off isn't as deep but it could only contain something the height between the Ground floor level and Level 1. This is a mystery that may be solved at a later date.

Top of piston at Level 1 (P9)

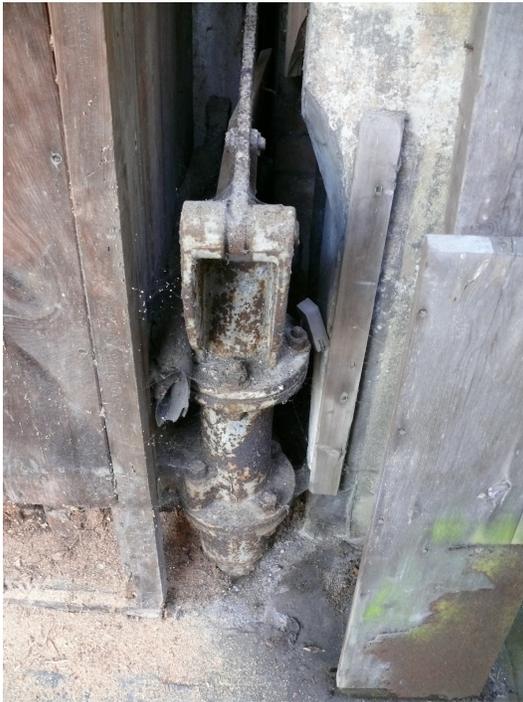
The valve (P7)

It can be seen in the photograph of the valve that below there is a pipe sunk into the floor. I was unable to ascertain whether this was the supply pipe or a drain pipe but the photograph of the bottom of the valve shows another pipe in the ground floor housing which also appears to go into the floor. This is why I conclude that there was probably a supply pipe and a drain pipe.

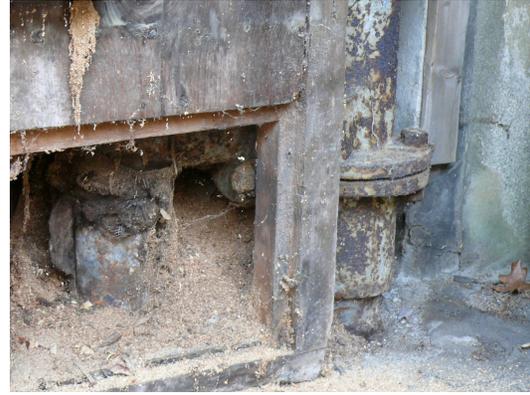
The bottom of the valve (P4)

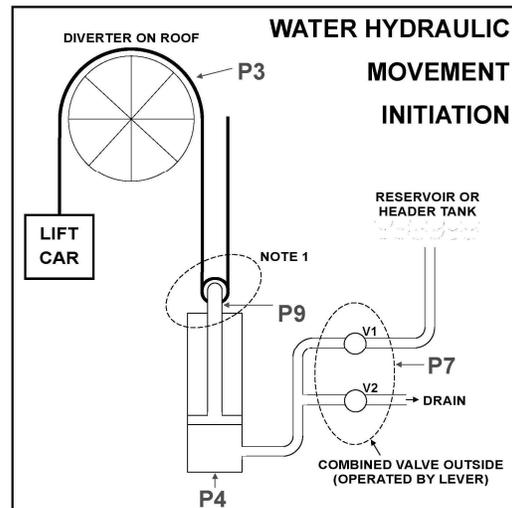
It is known that in 1884 that Waygood developed a water hydraulic lift with an accumulator however I could find no evidence of an accumulator and given that there is a drain pipe it would appear that the lift is lowered by filling the cylinder and extending the piston and raised by allowing the water to dump to a drain.

That being the case the piston end must weigh more than the car and the water pressure must be sufficient to overcome the weight of the piston.

A possible solution for how the lift worked is shown below. The numbers on the drawing (e.g. P9) refer to the photographs within this article.

Possible solution (P8)

Note 1: Given the height of the cylinder there must have been a diverter to achieve full shaft travel.

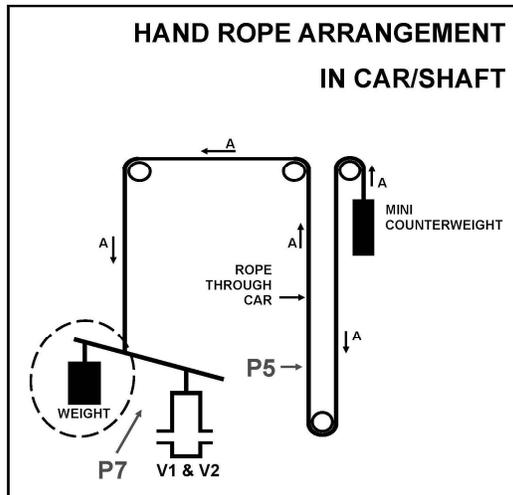
The hand rope has a complicated reeving arrangement and this arrangement is shown below:

The hand rope arrangement

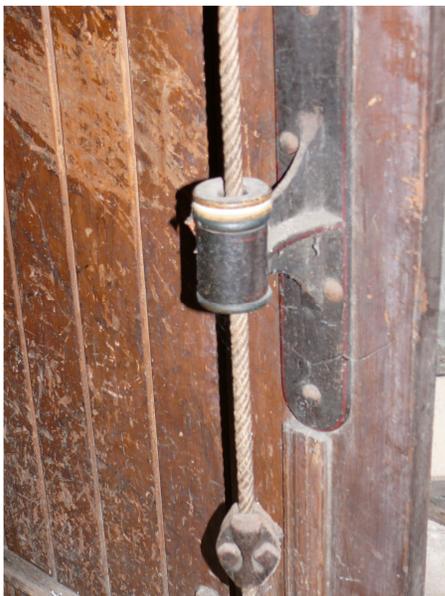
Movement of the car is initiated by a hand rope which runs through the lift car and up & down the shaft via a number of pulleys.

The hand rope has a counterweight on one end and ends up attached to the lever which is attached to the valve in the courtyard. Although I couldn't get to the end of the lever which was behind the back of the lift car and not accessible from outside it must be the case that it is weighted such that there is no gain from the hand rope counterweight as its function is purely to keep the hand rope taut.

The Handrope (P1)

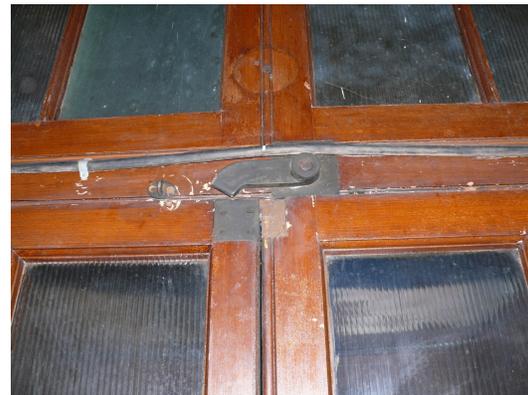
The door locks operate by simple levers by the action of the lift car being at a landing. The door locking arms themselves are found on the outside of the landing doors as can be seen in the photograph below.

Landing Door Lock (P2)
